Energy auditing and weatherization with thermal imagers

Application Note

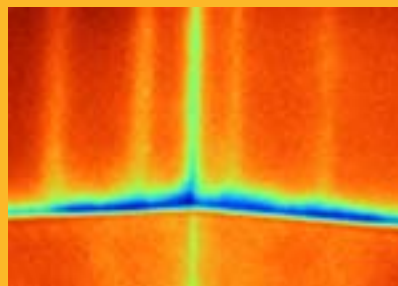
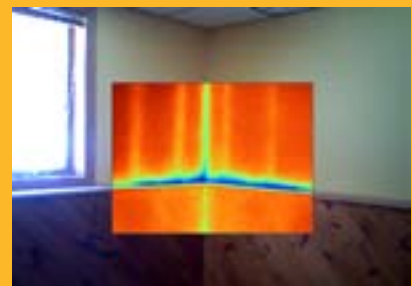
Picture-in-Picture, an IR-Fusion viewing mode, takes the guesswork out of re-locating problems by providing a frame of reference such as in this infrared image of an air leak at the point where an exterior wall meets the foundation.

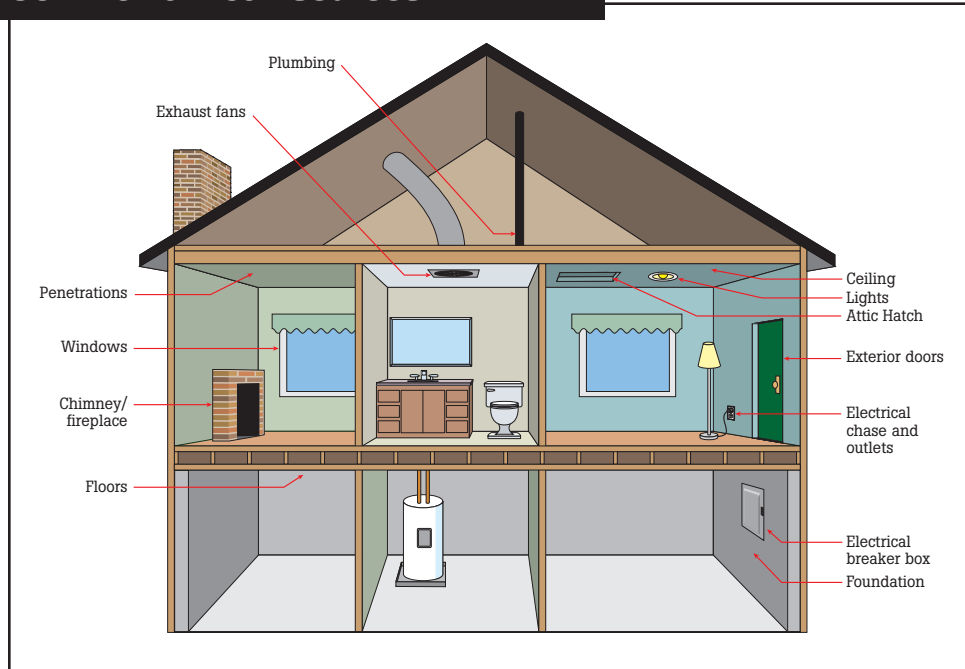
Common air leak sources

Significant air leaks tend to occur near attics and basements due to the stack effect. The stack effect occurs when warm air rising in a home creates an area of low pressure at the lower levels and high pressure near the roof. These pressure differences force warm air to escape from the top and cold air to enter near the bottom. Other common areas of air leakage are highlighted in Figure 2.

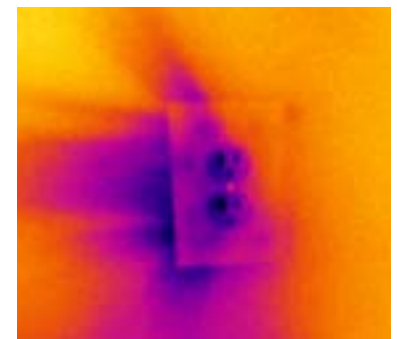
A blower door was used to increase the air flow around this outlet. Thermal imagers don't see the actual air moving but instead see the effect it has on a surface. Outlets and switches that are not properly sealed add to overall air leakage.

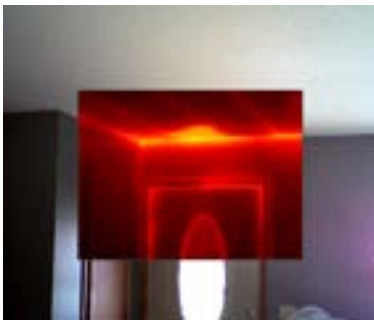
Recessed blown-in attic insulation

It's much easier to interpret findings if the type of insulation is known. Knowing the insulation type enables an auditor to prepare for issues commonly associated with certain insulation types. For example, blown-in insulation is notorious for settling over time.
